Inspection Report

12.07.2009

8616 Rolling Mountain Road
Charlotte NC 28228

Prepared For: Fred Johnson
Susan Johnson
Report #: T47U24R6706

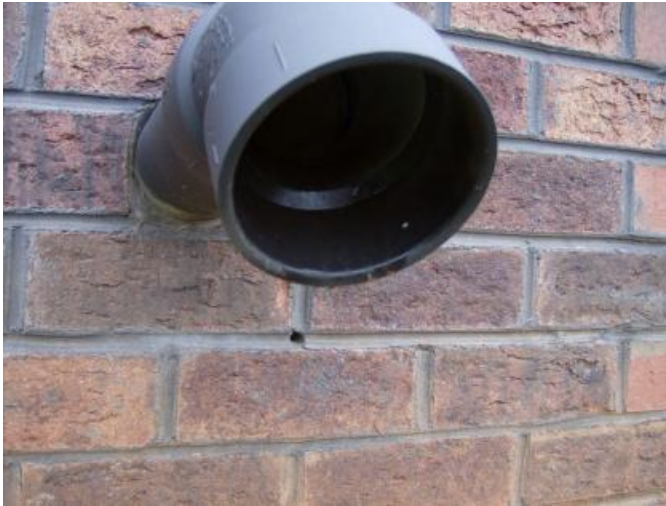
View of flue pipe missing the entrance screen

The furnace in the crawl space should have a screen placed over the opening of the flue pipe to prevent pest from entering. A repair professional should make any needed repairs.

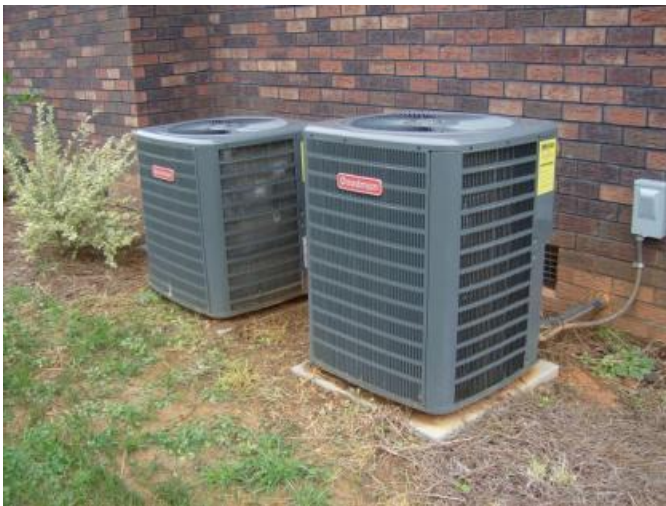
View of AC units

The air conditioner serving the main level was not tested due manufacturer's recommendations not to operate when the outdoor temperature is less than 65 degrees. Unit should be serviced by a HVAC professional.

Cooling function of heat pump at the second floor was not tested due manufacturers recommendations not to operate when the outdoor temp. is less than 65 degrees. Unit should be serviced by a qualified HVAC professional before closing.

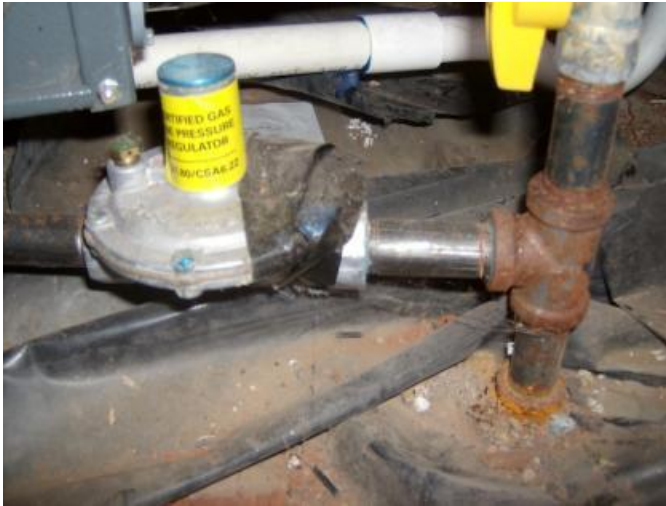
View of gas regulator at the crawl space furnace.

The gas valve was found to be taped up and the smell of gas was noted in the crawl space at the HVAC unit. The furnace also would continue to start and stop in a very short period of time. When running the furnace had a rumbling noise. I turned the unit off at the crawl space switch because I felt it was not safe. The unit should be serviced and any needed repairs by a qualified professional before moving into.
